**DEPARTMENT OF TRANSPORTATION****DIVISION OF ENGINEERING SERVICES**

Contract #: 04-0120F4Cty: SF/ALA Rte: 80 PM: 13.2/13.9File #: 1.28**WELDING INSPECTION REPORT****Resident Engineer:** Casey, William**Address:** 333 Burma Road**City:** Oakland, CA 94607**Report No:** WIR-027422**Date Inspected:** 09-Apr-2012**Project Name:** SAS Superstructure**OSM Arrival Time:** 700**Prime Contractor:** American Bridge/Fluor Enterprises, a JV**OSM Departure Time:** 1530**Contractor:** American Bridge/Fluor Enterprises, a JV**Location:** Job Site**CWI Name:** As noted below**CWI Present:** Yes No**Inspected CWI report:** Yes No N/A**Rod Oven in Use:** Yes No N/A**Electrode to specification:** Yes No N/A**Weld Procedures Followed:** Yes No N/A**Qualified Welders:** Yes No N/A**Verified Joint Fit-up:** Yes No N/A**Approved Drawings:** Yes No N/A**Approved WPS:** Yes No N/A**Delayed / Cancelled:** Yes No N/A**Bridge No:** 34-0006**Component:** SAS OBG**Summary of Items Observed:**

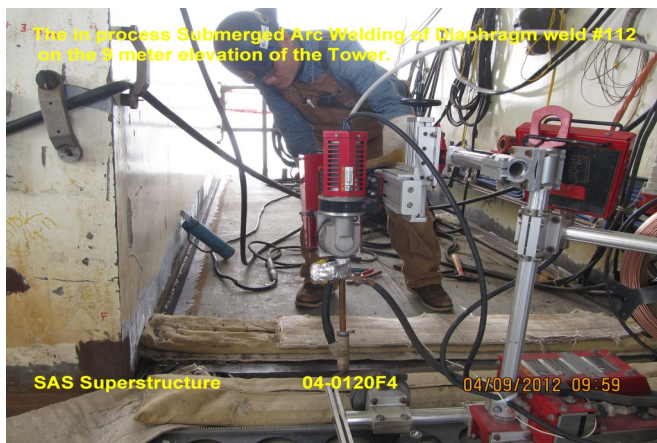
This QA Inspector randomly observed ABF welder James Zhen operating a Lincoln track mounted wire feeder to perform Submerged Arc Welding (SAW) in the 1G position on the diaphragm plate weld # 112 at the 13M elevation on the Tower. QC Inspector Fred Von Hoff stated the pre-heating of the joint was applied to 225° F prior to the commencement of welding and the parameters were recorded as 550 amperes at 32.5 volts with a travel speed of 380mm/min equaling a heat input of 2.8 joules/mm. This QA Inspector observed the baking oven for the ESAB EN 760 Flux and noted the temperature setting at 200° F. On a subsequent observation, this QA Inspector observed ABF welding personnel recycle the flux utilizing a vacuum hose and cleaning the edge of the work with a chipping hammer between passes. Mr. Zhen was observed adjusting the path of the feeder prior to each consecutive pass during the ongoing process and inspected each completed pass for indications and workmanship. This QA Inspector made subsequent observations throughout the shift to monitor quality and noted that the work was in progress and appeared to be in general conformance with ABF-WPS-D1.5-4062-1 and the contract specifications.
